Project Case Study: Source to Tap—Project update

Peat, sleep, restore afforested blanket bog, re-peat

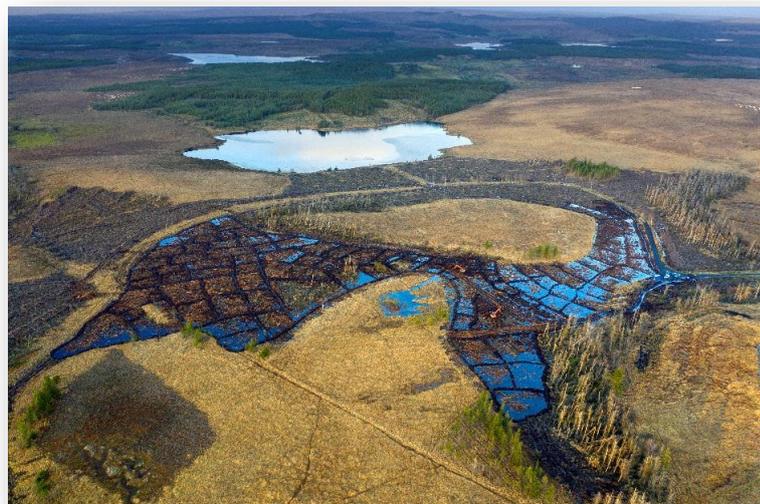
Some of the recently created cell bunds filling up with water.

Diggers arrived on site on 22nd October to start work on the cell bunding area. In this area a trench is dug, approximately 1m deep through the damaged top layer of peat and a low bund wall made from saturated peat is built up and compressed along 4 sides to form a watertight cell. As the site contains tree stumps and brash these must be avoided when building the bund walls.

Despite difficult ground conditions, over 10 weeks or so approximately 140 cell bunds have been constructed. Shortly after the cells were created they were already retaining water. Work is well underway in blocking the drains on the site every 12m or so using peat dams. Once all the work is completed, monitoring using shallow groundwater piezometers will be carried out on the site to compare the recovery of the water table in each of the different sections.
